PROJECT REPRESENTATIVE'S DAILY REPORT

Pg. 1
Report No. 089
Date: 2014-12-24
Day: Wednesday

Project: Renovation and Addition to Tewksbury Town Hall

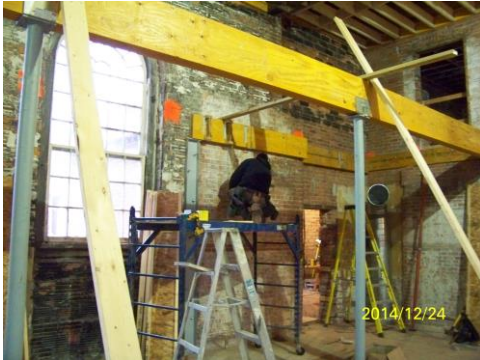
Photo showing carpenter working on the 2nd floor framing along the northeast corner of the meeting hall.

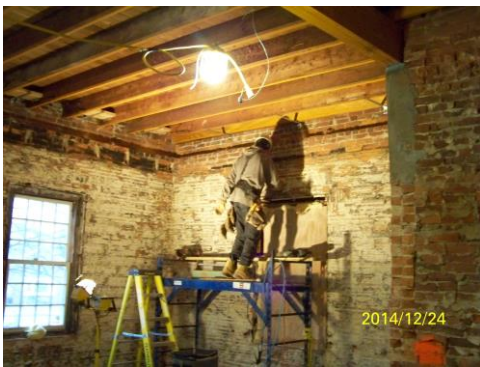
Photo showing carpenter installing tie-backs along the east elevation of the north wing at the roof line.

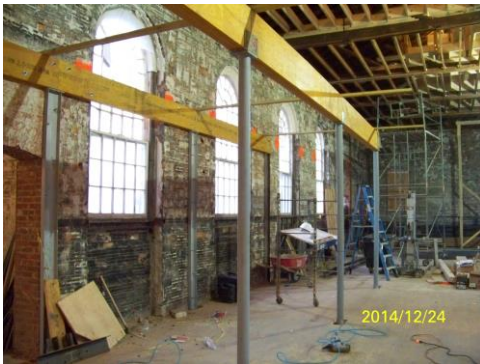
Photo showing 2nd floor framing in the southeast corner of the meeting hall.

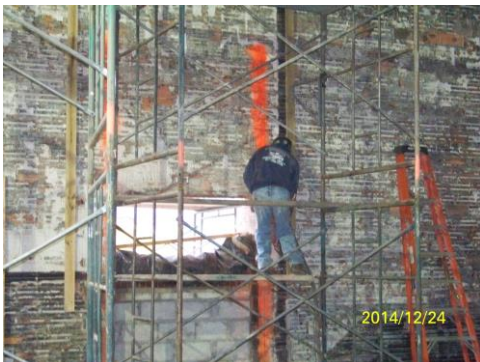
Photo showing mason cutting for the new window opening at the south elevation of the meeting hall.

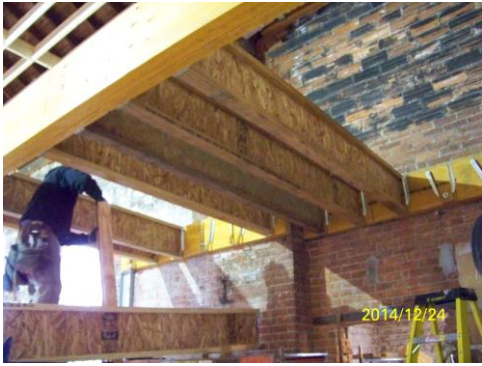
Photo showing joists being installed for the 2nd floor.

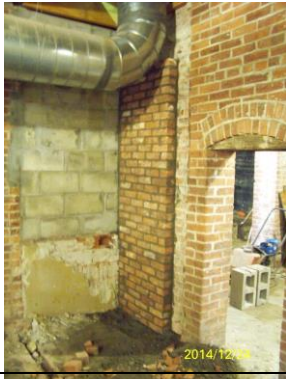
Photo showing build out of masonry wall in the basement for a new doorway.

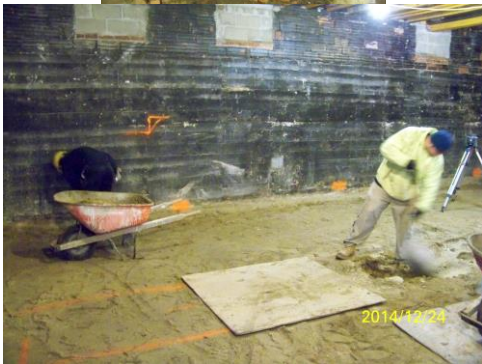
Photo showing workmen prepping the subfloor in the north wing of the basement. This is where the new vault will be located.

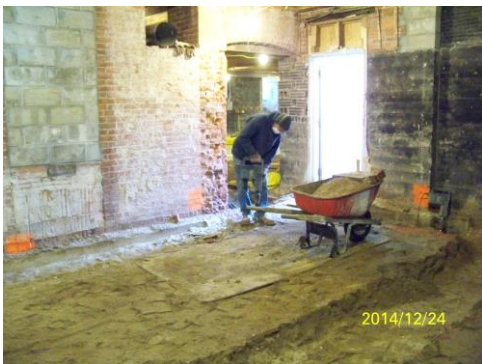
Photo showing workman trenching for the new footings.

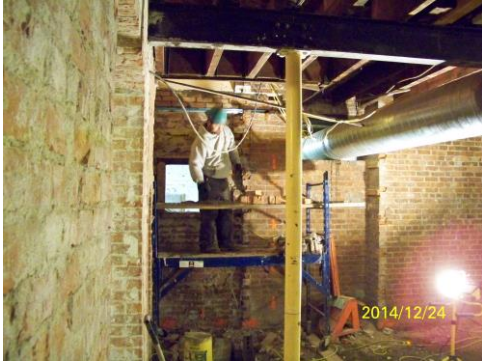
Photo showing mason working on a new doorway opening.

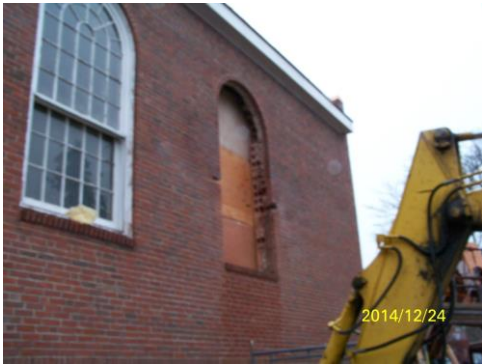
Photo showing the new window opening on the north elevation of the meeting hall.
